## Flood Vulnerability and Coping Capacity : Vetiver Plantation

## Bongaigaon Initiative

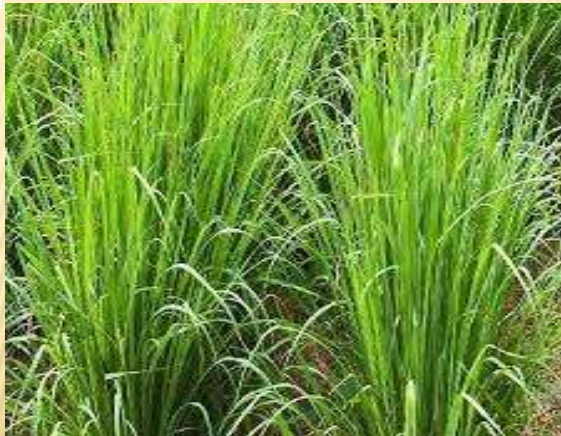
Vetiver Grass

- ✓ Extremely deep root system, capable of reaching down to two to three metres in the first year itself.
- ✓ Extensive and thick root system binds the soil.
- ✓ When planted close together, reduces the flow velocity, diverting runoff water and forming a very effective filter.

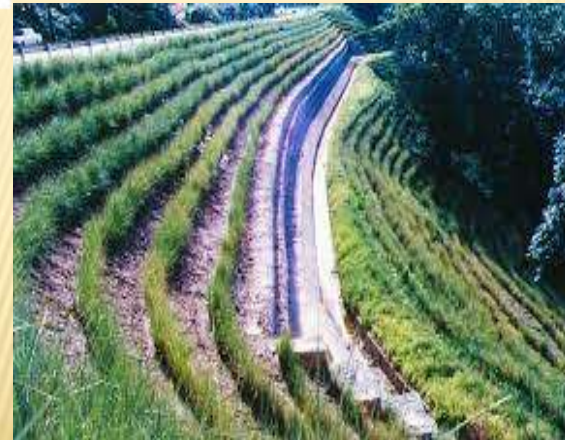
Vetiver for Slope Stabilization

- ✓ Bio-engineering tools for preventing erosion and slope stabilization-sustainable bio-engineering technique.
- ✓ Roots are very sturdy which increases the shear strength of soil, thereby enhances slope stability appreciably.
- ✓ Highly tolerant to adverse growing conditions such as extreme soil pH, temperatures and heavy metal toxicities.
- ✓ Successfully implemented in Australia, China, Thailand, Philippines and other many countries countries.
- ✓ In India, the present study of Bongaigaon, Assam.

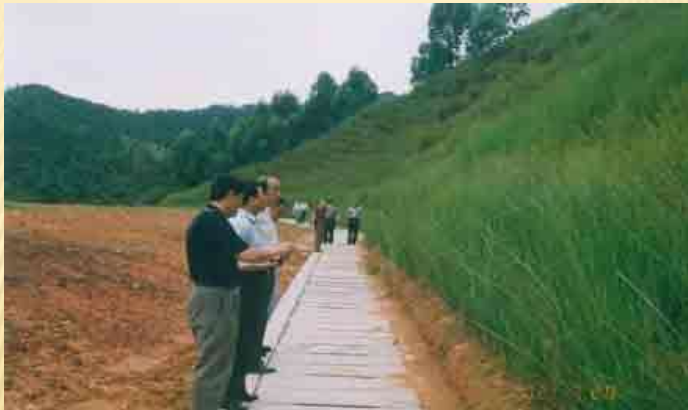
China slope protection project

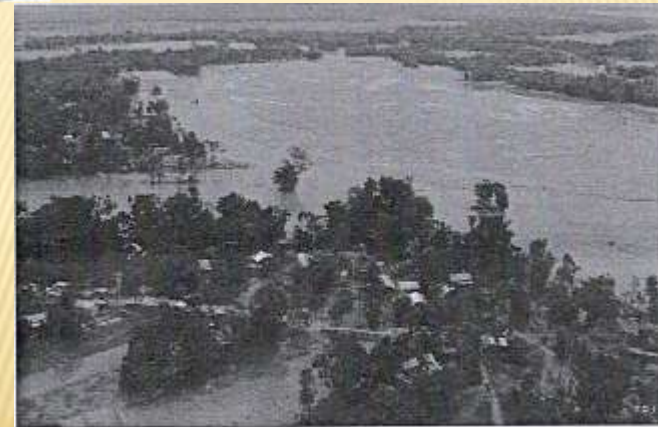
Aie R in Spate

- ✓ Aie R originates at the foothills of Bhutan and travels 51 km within Bhutan and thereafter 98 km in Assam before merges with Brahmaputra.
- ✓ Aie R joins Manas at Santoshpur, Bongaigaon.
- ✓ Caused by the bursting of river banks due to heavy and high intensity of rainfall during the monsoon season.
- ✓ In the year 2020, floods occurred mainly due to diversion of oblique channel of river.
